# Manhole Inspection Summary

Manhole # S49CC\_057MH

Insp Date: **2/18/08 12:14 PM**

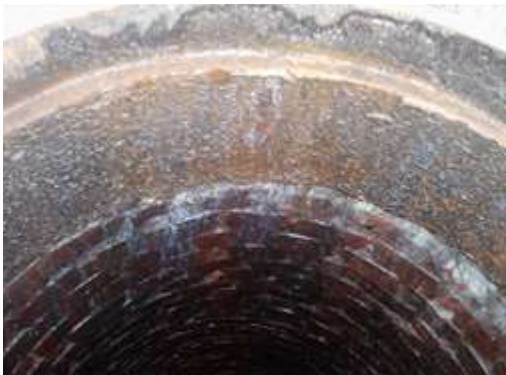
Defect 1

Adjustment Joint

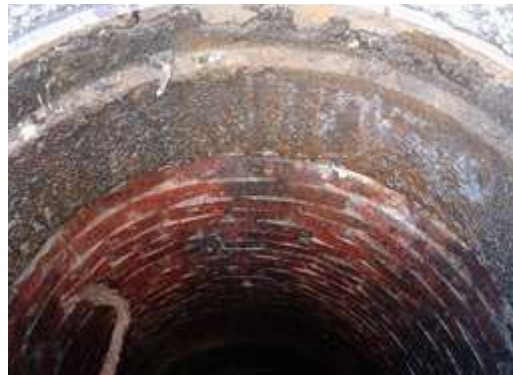
Defect 2

**Frame** Offset: **0** (in.) Condition: ☐ Sound ☐ Cracked ☒ **Leaks**

Frame Leaks

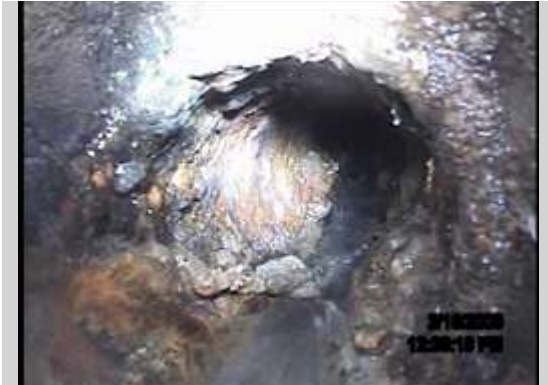
12 O'Clock Outflow

8 in. Circular Gravity Sewer  
Pipe Out @ 12 O'Clock

Pipe Height: **8.4** (in.) Rod and Bar (Angled)  
Pipe Material: **Clay** ☐ Pipe Lined  
Invert Depth: **13.30** (ft.) Flow Characteristics: **Fast**  
Deposits: ☐ None ☐ Mud ☒ **Sludge** ☐ Debris ☐ Grease  
Silt Depth: **2** (in.) Deposits Extent: **Medium**  
Infiltration: **None** Pipe Seal Cond: **Sound**

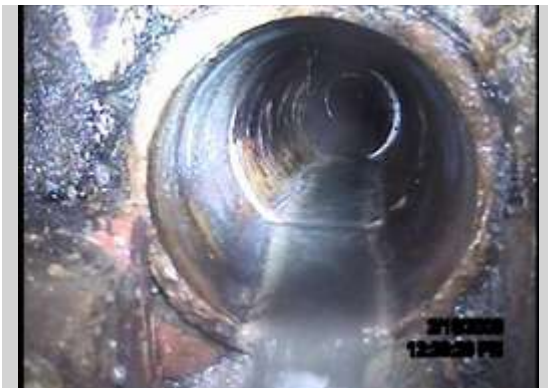
4 O'Clock Inflow

8 in. Circular Gravity Sewer  
Pipe In @ 4 O'Clock

Pipe Height: **8.4** (in.) Rod and Bar (Angled)  
Pipe Material: **Clay** ☐ Pipe Lined  
Invert Depth: **11.49** (ft.) Flow Characteristics: **Fast**  
Deposits: ☒ **None** ☐ Mud ☐ Sludge ☐ Debris ☐ Grease  
Silt Depth: (in.) Deposits Extent:  
Infiltration: **None** Pipe Seal Cond: **Sound**
